GRATONCOMMUNITY SERVICES DISTRICT

- **DATE:** November 14th, 2022
- **TO:** Members of the Board of Directors
- **FROM:** John Gibson, Chief Plant Operator

SUBJECT: OPERATION REPORT, October 11th – November 14th 2022

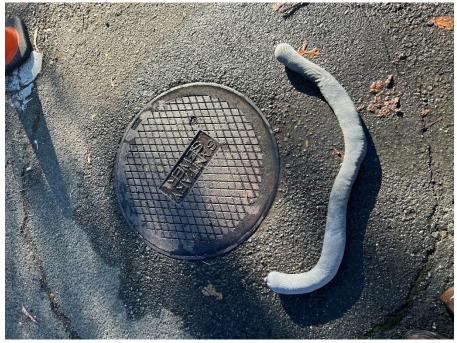
On November 10th a sewer backup occurred at manhole MH 7-2 on the corner of Graton road and Cecile Street. The backup was minor and estimated less than 5 gallons had seeped from around the manhole lid. Operators responded immediately and set up a portable trash pump with 3" hoses and began pumping the sewage downstream to the next clear manhole. MSI jetted the main from the downstream manhole MH 7-3 up to MH 7-2 and screened the debris. The cause of the backup is due to root intrusion in the line leading to buildup and clogging of the main. The sewage that seeped from the manhole was cleaned up with absorbent pads and contained, the area then disinfected with a solution of bleach and water. MSI will provide the District

with a quote to CCTV the line and options for repair.
