Sanitary Sewer System Preliminary Engineer's Report

Graton Community Services District

Project No. 1088-40-24-03

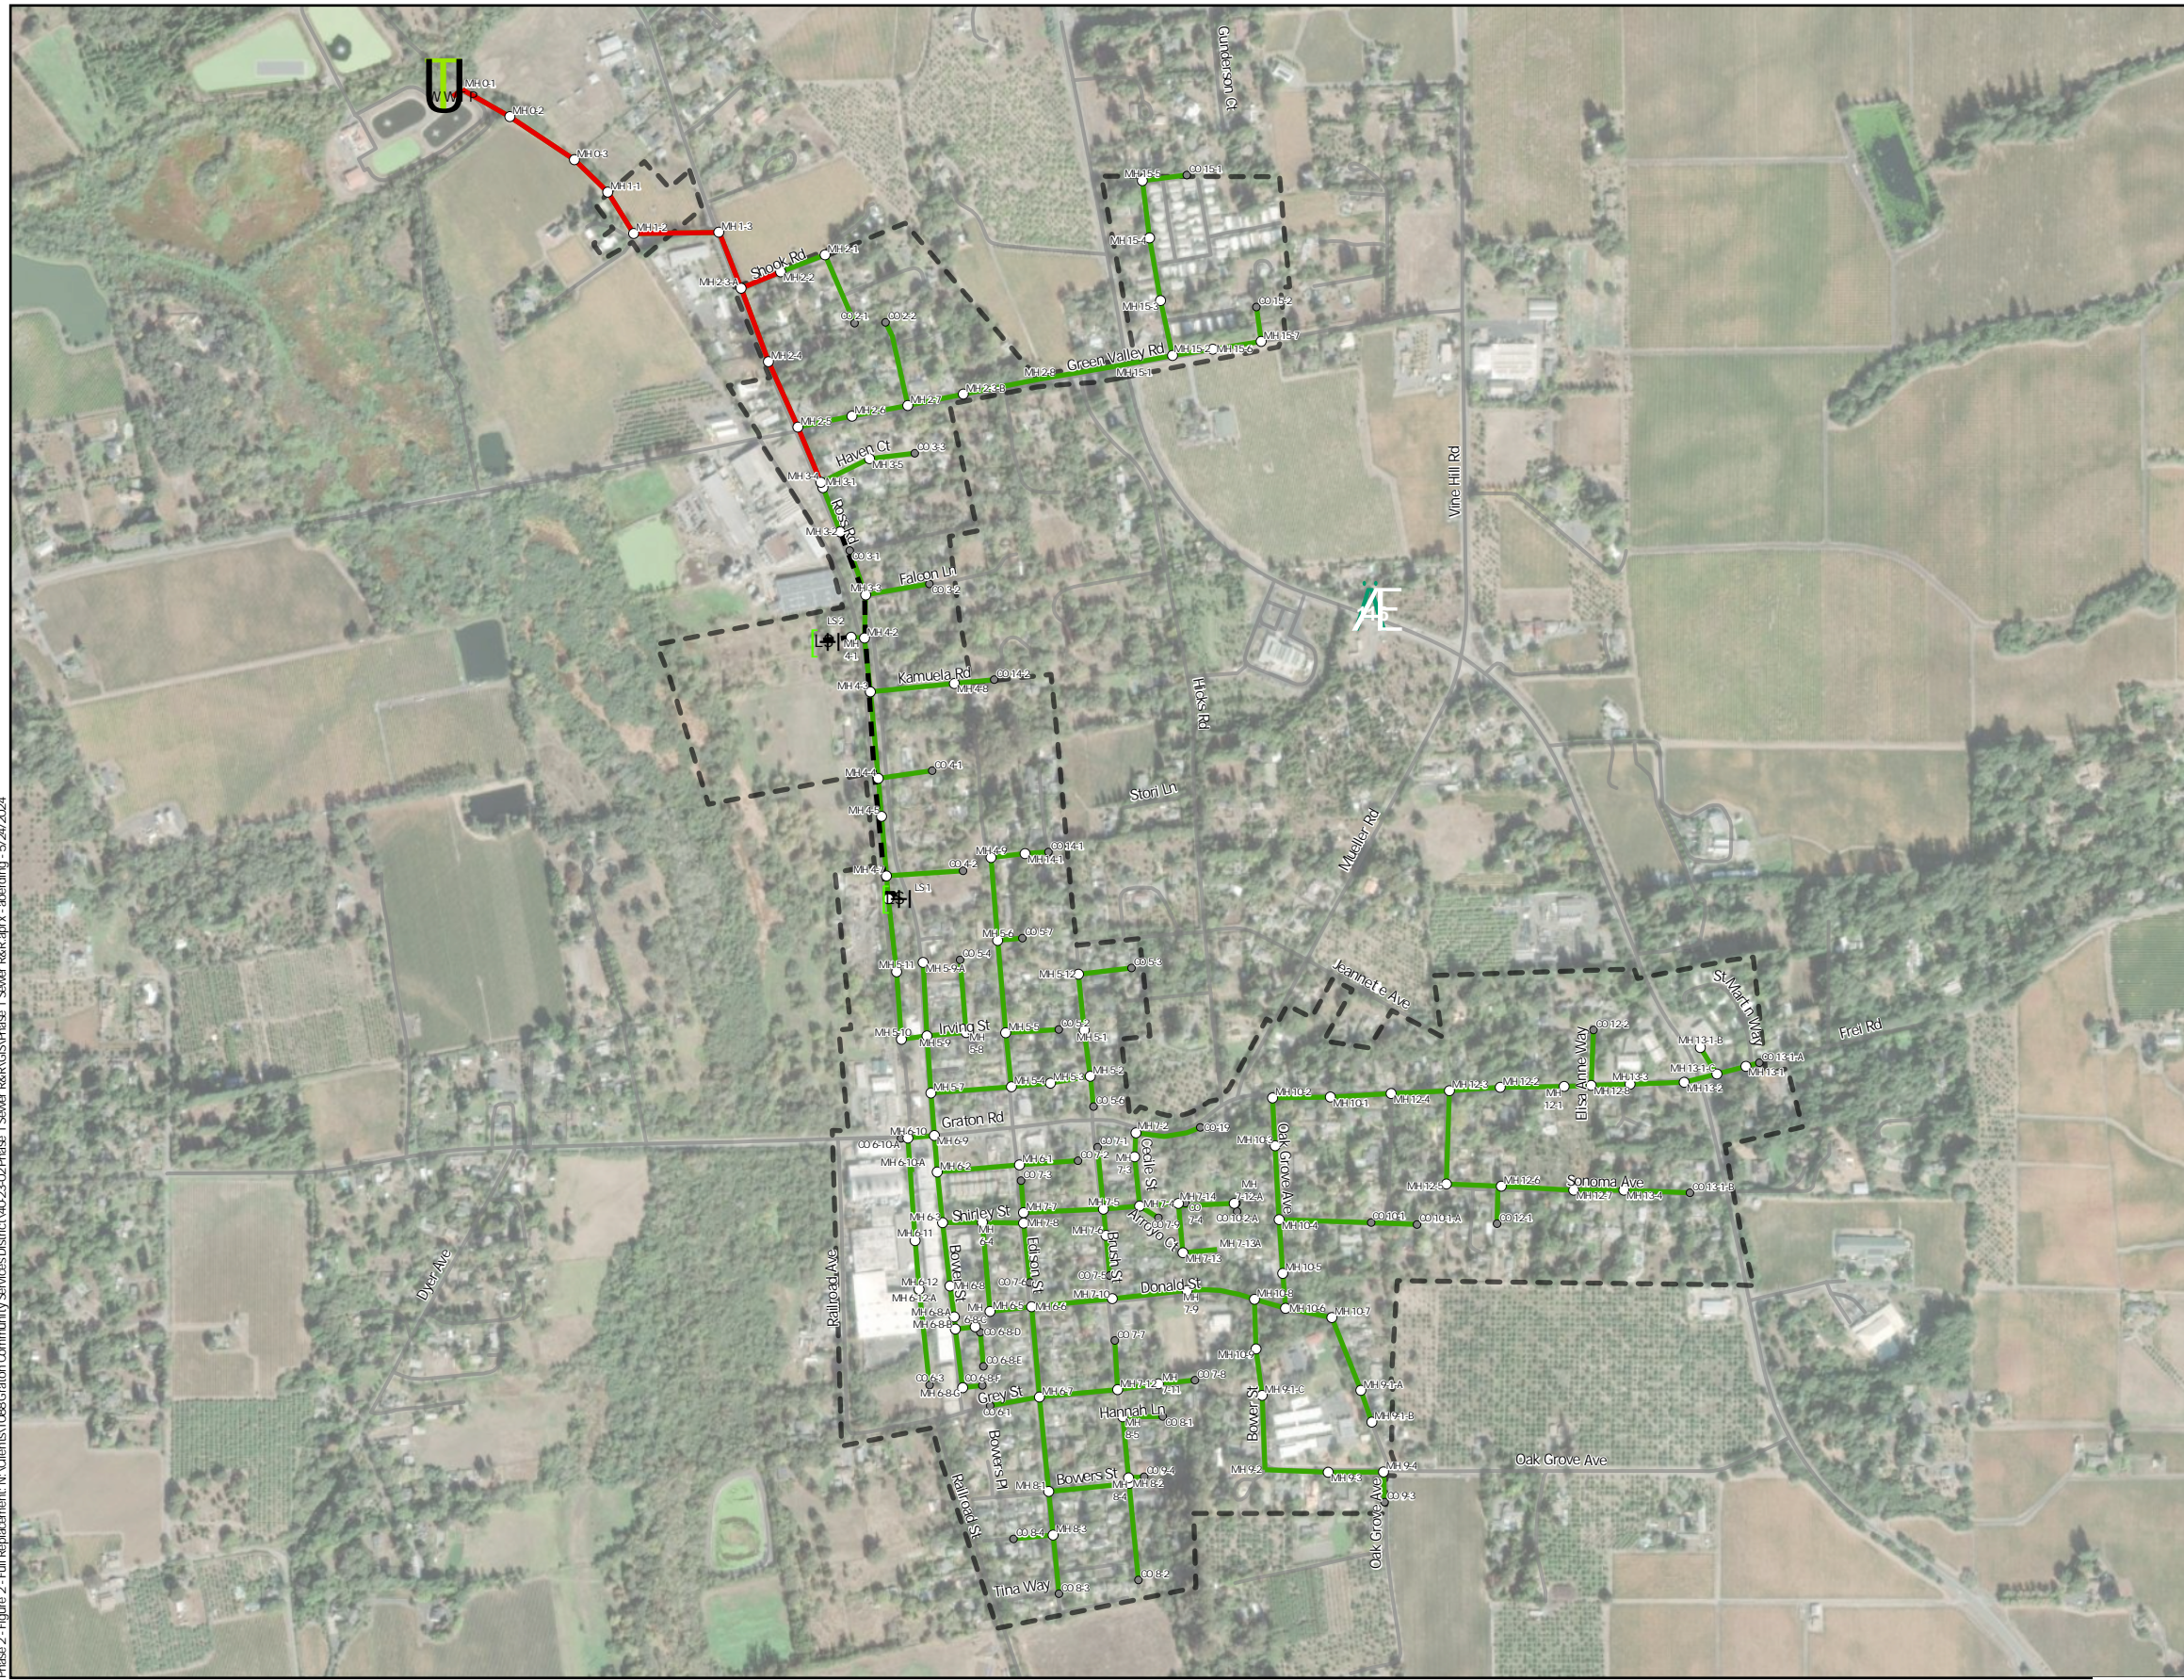
Gravity Pipelines Recommended
for Full Replacement

AC pipe material is characteristically long-lasting and inert. However, over time the pipe can deteriorate when exposed to corrosive sewer fluids and gases. It is clear from the CCTV inspection that some sections of the pipe will need to be entirely replaced. These sections are listed in Table 6-1, and shown in Figure 2.

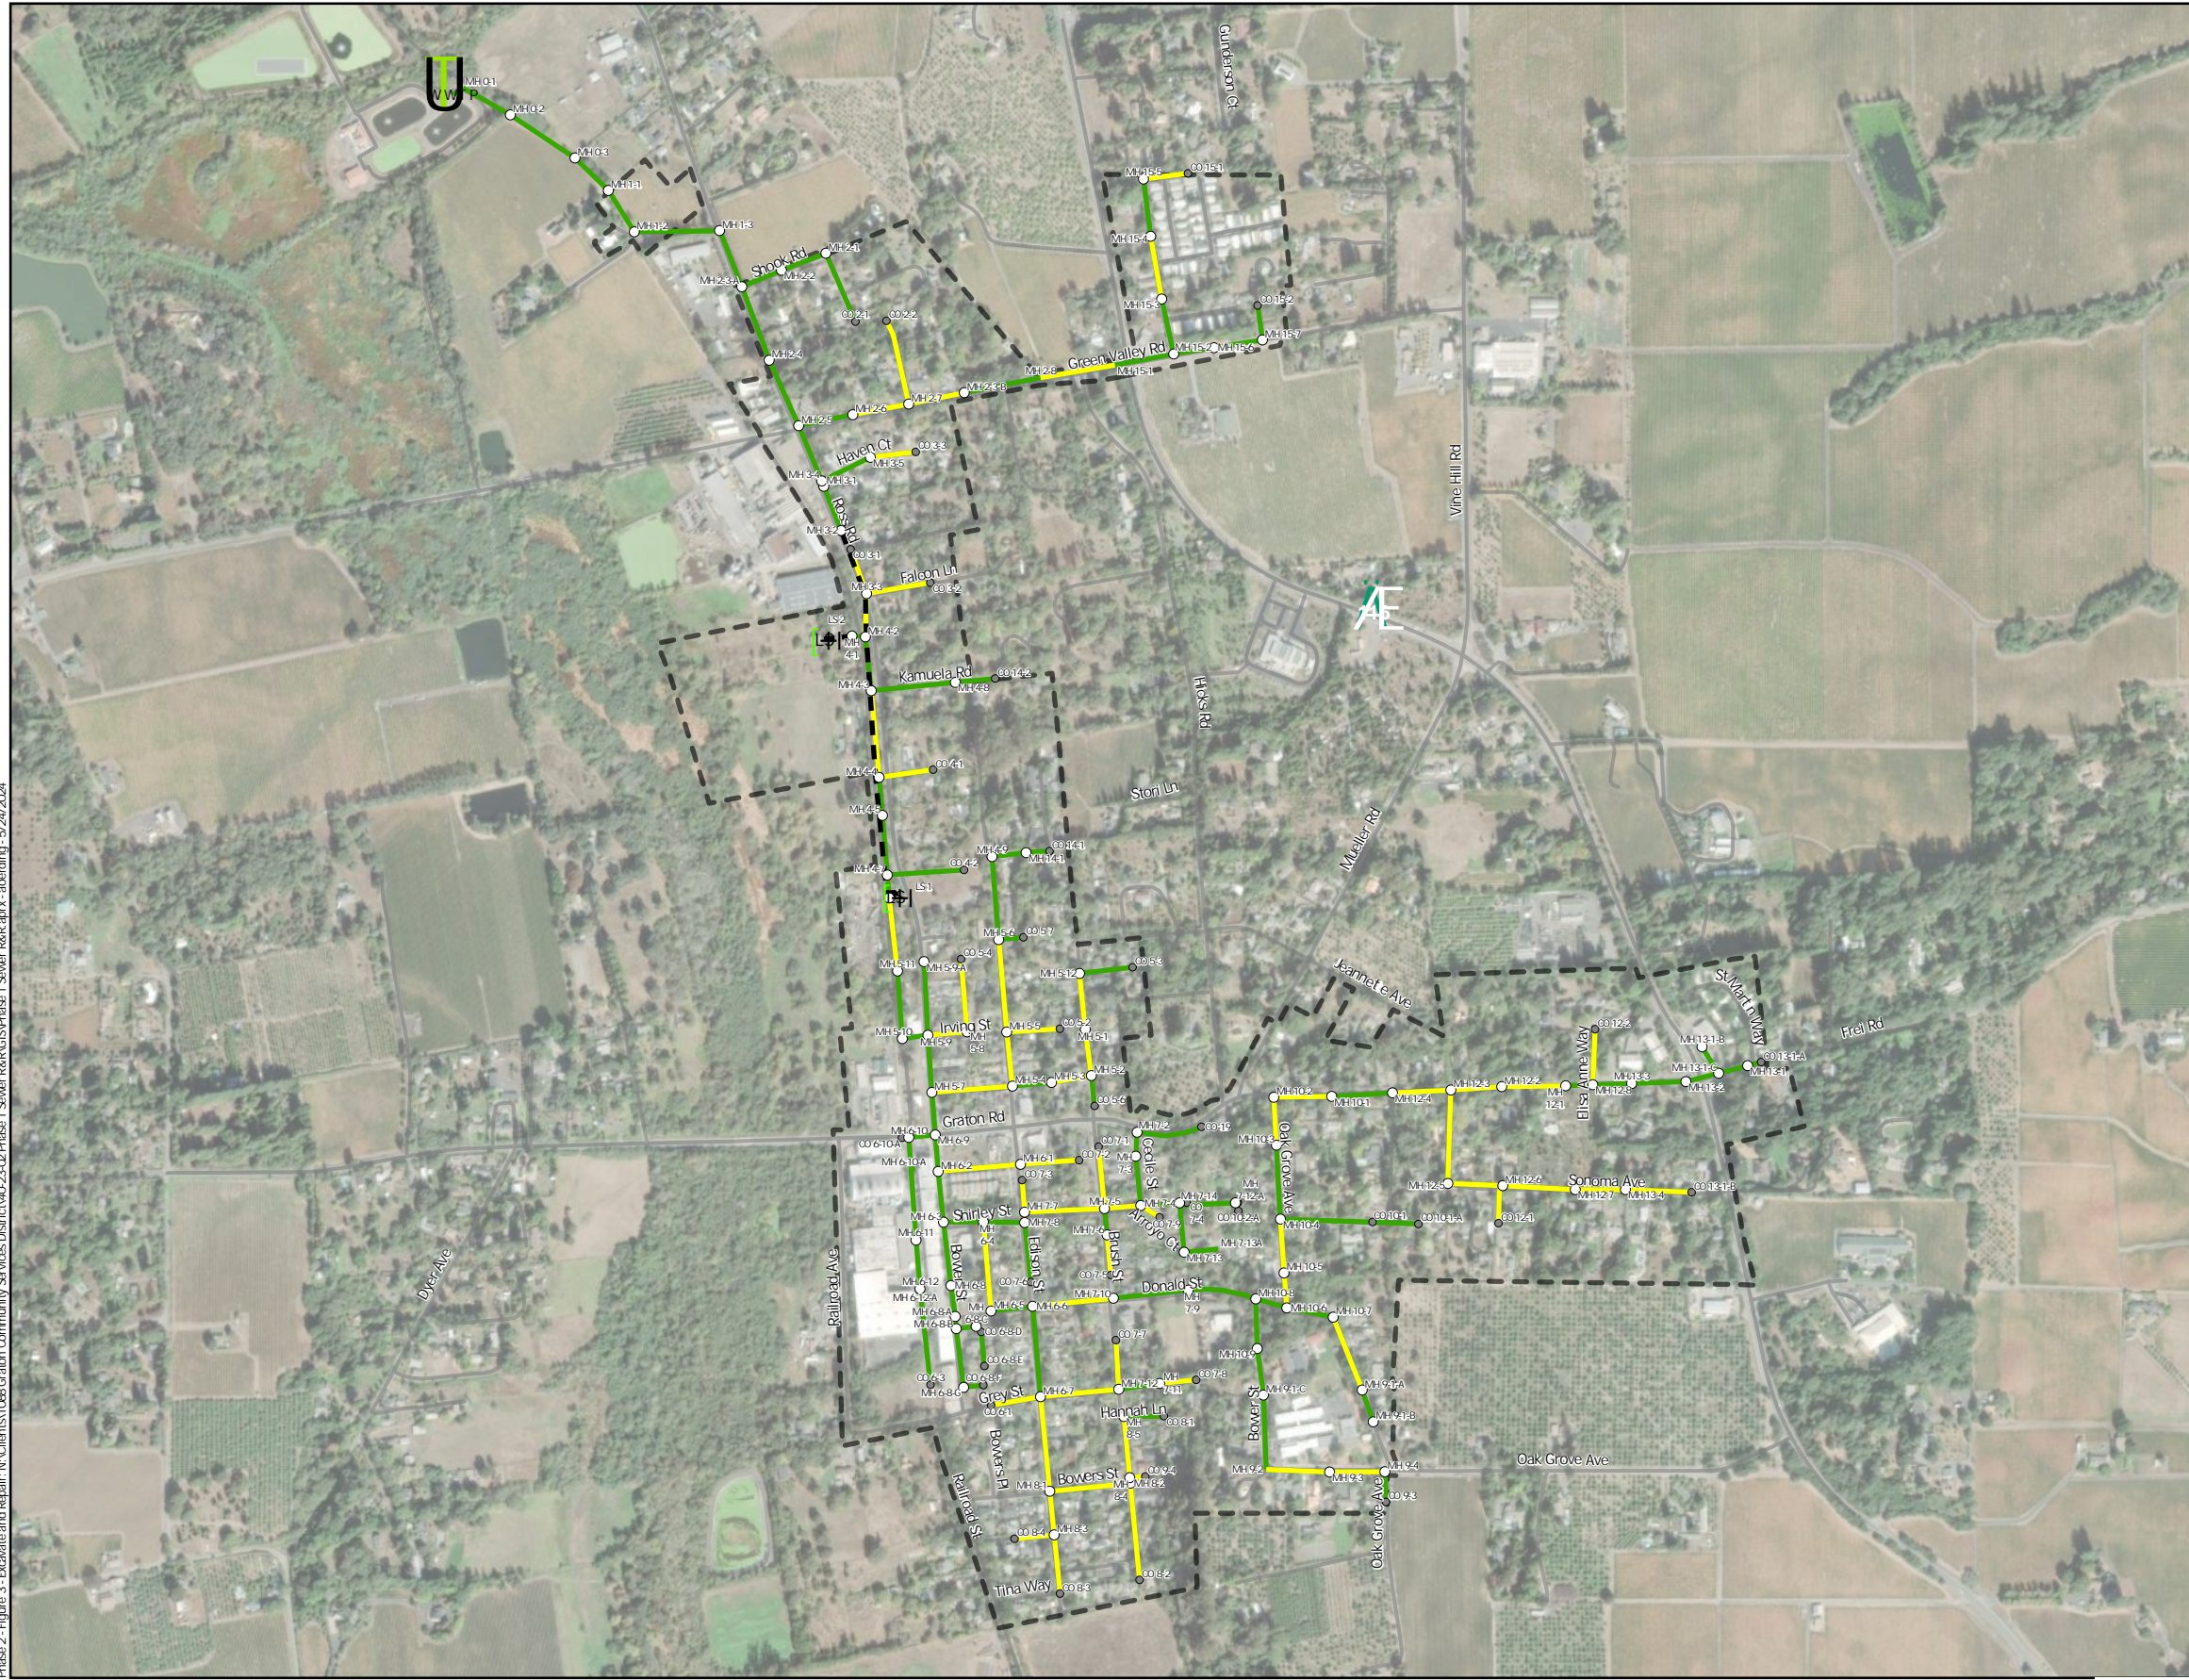
Excavate and Repair

The vast majority of the observed defects are related to various misalignments or separations between pipe segments. For separations and small to medium offsets, it might be possible to avoid excavation and use trenchless technology, such as CIPP. Nonetheless, the majority of the sections that need to be remediated have significant offsets and trapped water that are both incompatible with liner application. For simplicity, the misaligned sections are being recommended for spot repair involving excavation, realignment of the pipe sections, the application of a proper backfill, and replacement of the soil and road surface. These are listed in Table 6-2 and shown in Figure 3. Pipes that could be suitable for CIPP are identified in Table 6-2 and will be considered during the next design phase based on costs and District preferences.
