# Graton CSD

Collection System Condition Assessment – Preliminary Results

December 2023

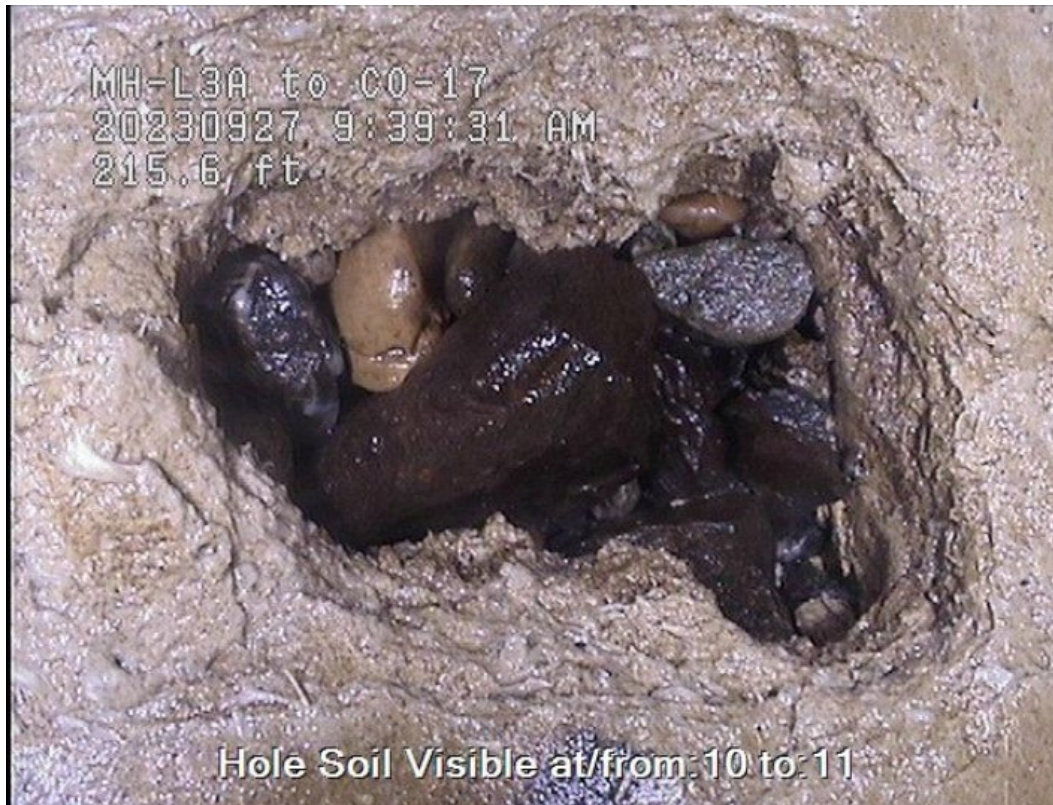
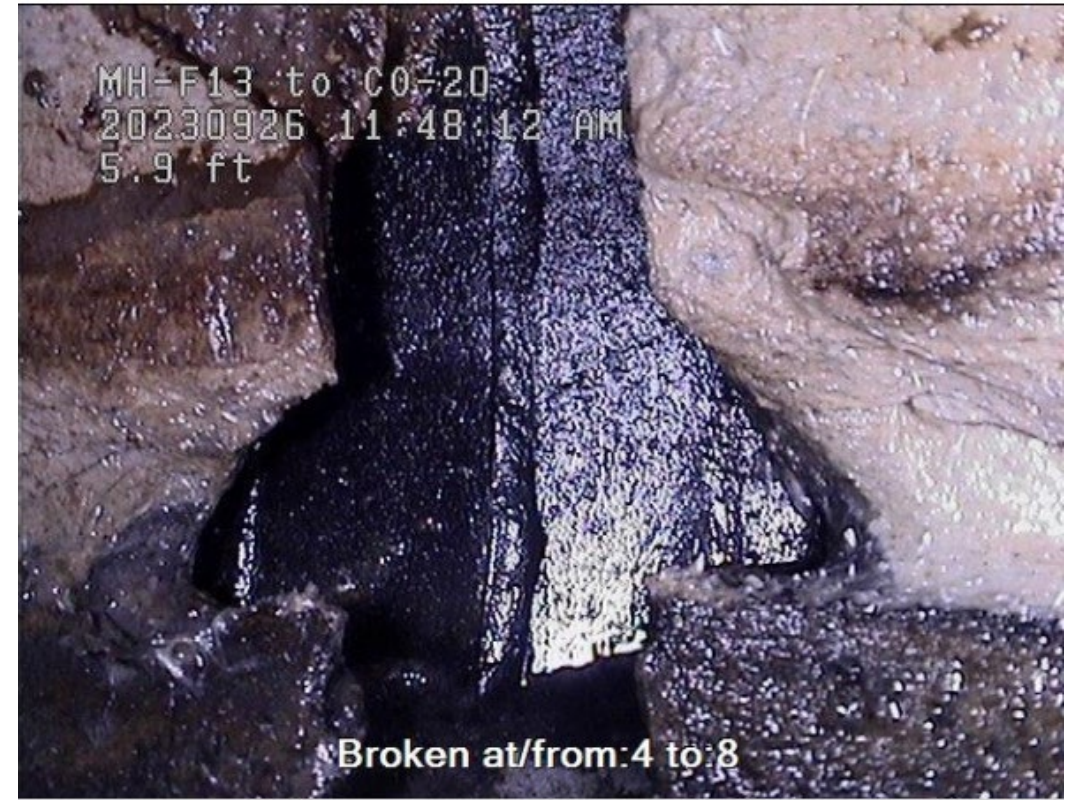
- Examples of Grade 5 Structural Defects

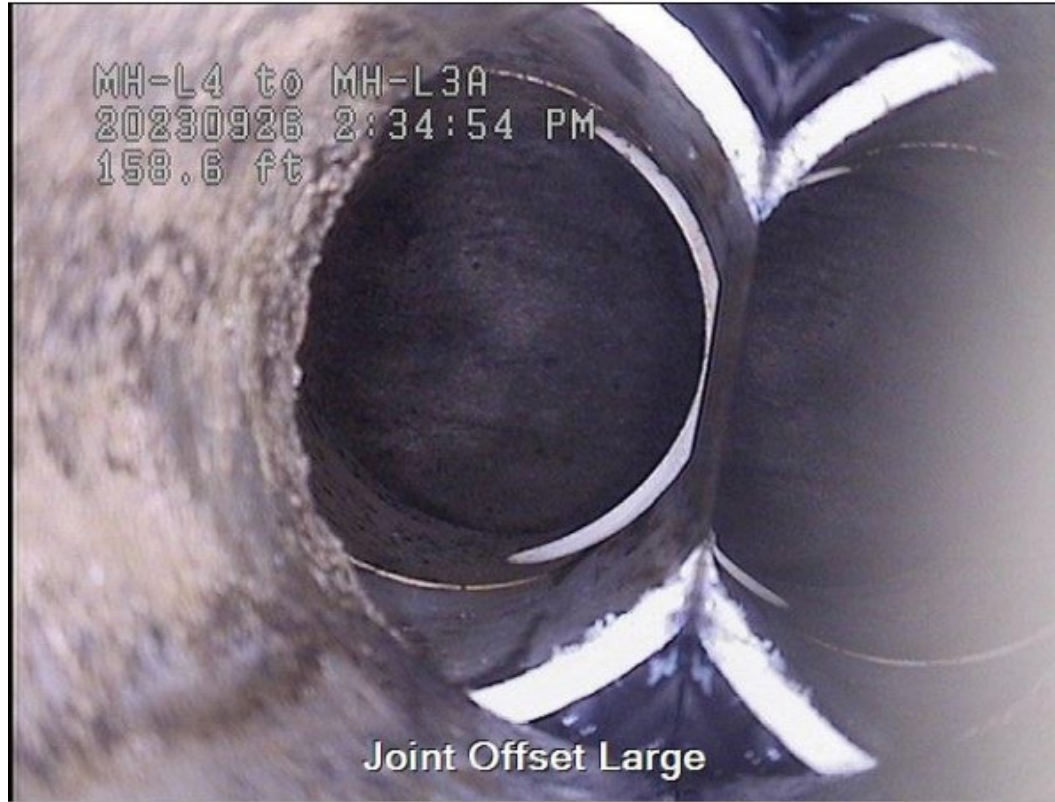
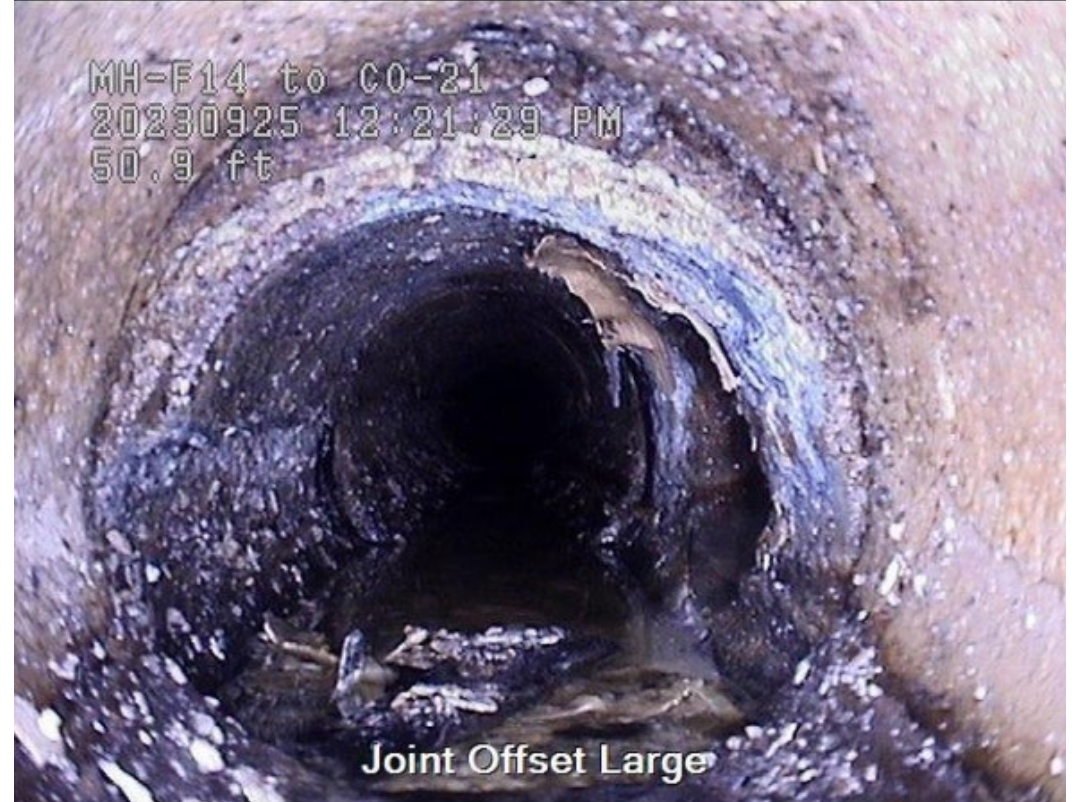
- Examples of Grade 4 & 5 Structural Defects

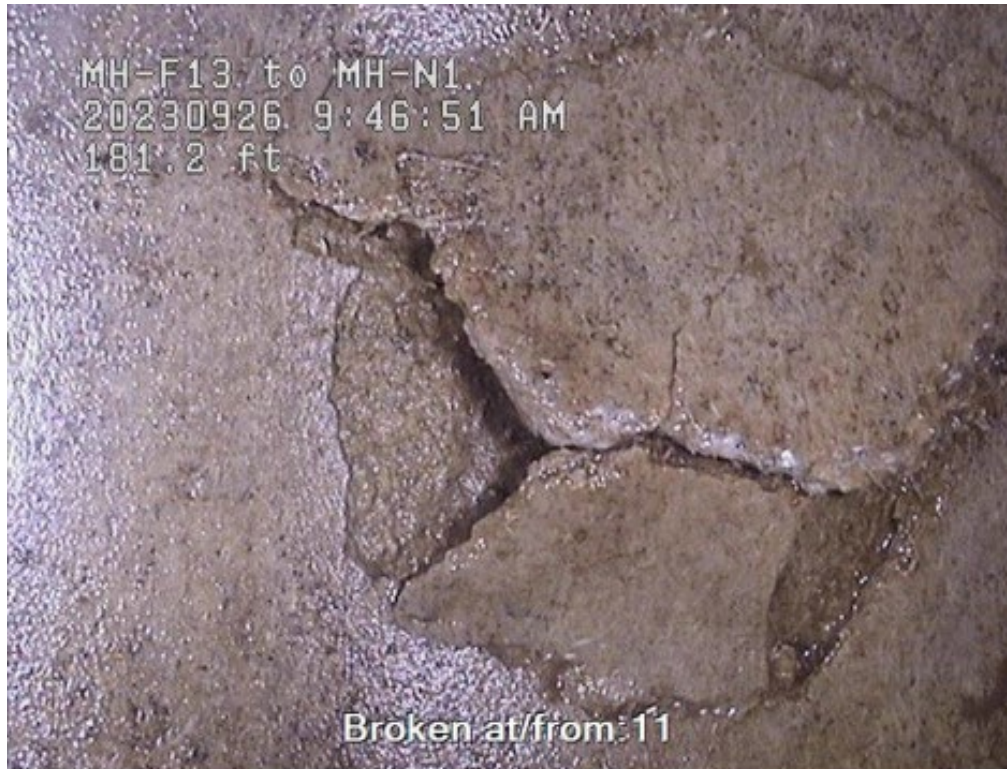
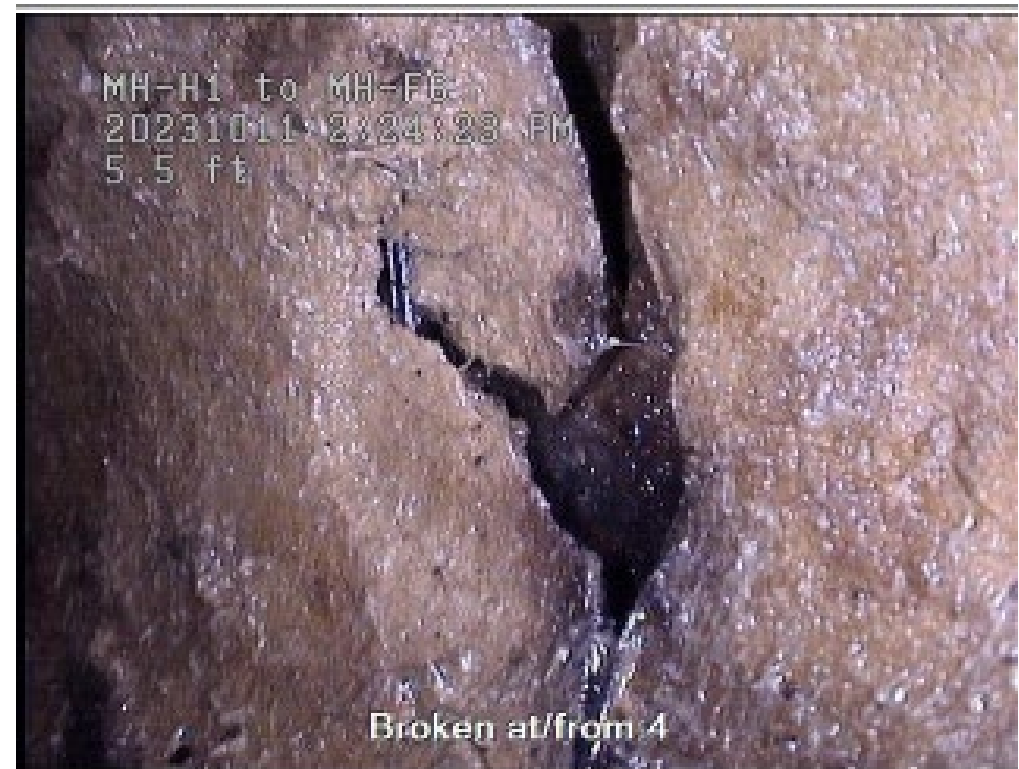
- Examples of Grade 4 & 5 Structural Defects

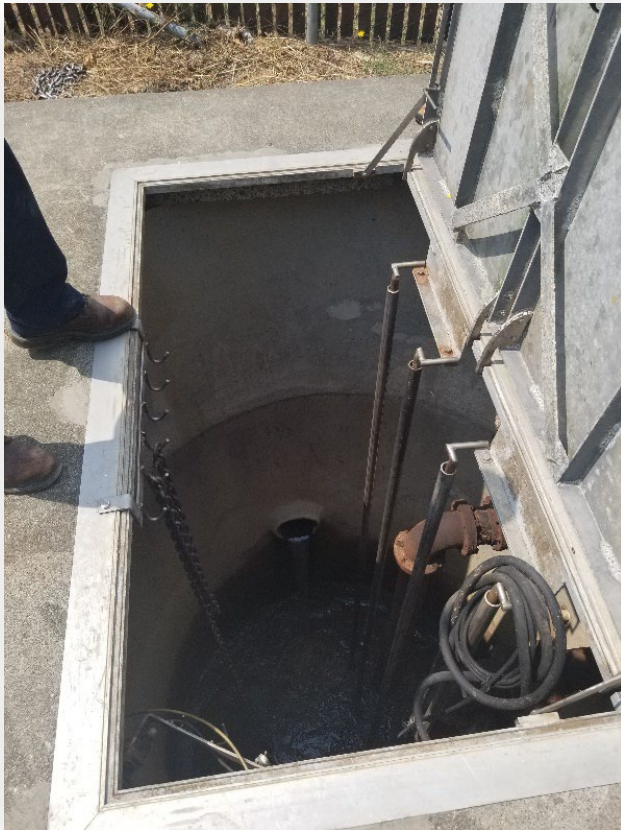
Wet well

Discharge piping in wet well	4	3	Corrosion along entire section. See Photo 1 below.	Replace
Water Service Well	3	1	Well on site, shared ownership with neighbor	None
Valve Vault	2	1	Concrete and grates in good condition; minor build up of sediment/debris in bottom of vault.	None
6-inch Plug Valve (x2)	3	1	Minor corrosion on valve body and major corrosion on bolts. Functionality of valves is unknown; due to potential risk of damaging valves and age, recommend to replace valves.	Replace
6-inch Check Valve (x2)	3	1	Minor corrosion on valve body and major corrosion on bolts. Due to age, recommend to replace valves.	Replace
Force Main	1	1	Replaced 1,600ft of forcemain approx. 10-years ago (asbestos piping); consider additional inspection of forcemain to determine condition.	Perform condition assessment of forcemain to determine condition and rehabilitation needs.
Hoist	2	3	Rust on bolts, otherwise in good condition. Portable hoist is unstable.	Consider installing more robust and permanent hoist.

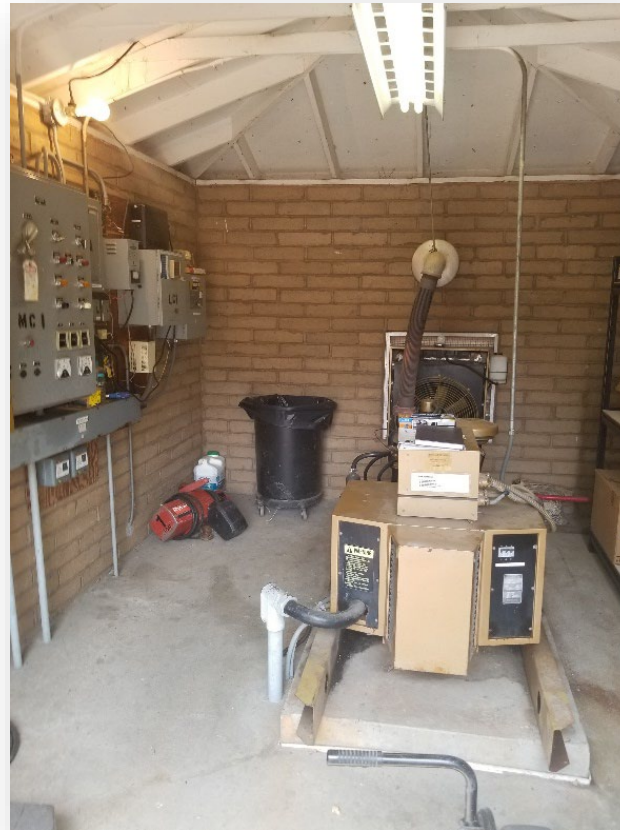
Generator and Building

Generator	4	3	Existing generator is not efficient and is obsolete; no parts available for repair and finding someone capable of work is difficult. See Photo 2 below.	Replace
Portable Bypass Pump	1	1	-	None
Site – yard, fencing, drainage	2	1	Chain-link fencing is in good shape but missing privacy slats. Recently extended and closed back of site due to vandalism of PG&E box	None
Access	2	1	Paved, and in good condition. See Photo 3 below.	None
Security	1	2	Gate around facility; locks on wet well access hatch, main gate, and structure gate/door. See Photo 3 below.	Consider installing more secure fencing and gate.
Structure	1	1	CMU and roof in good condition. Only repairs over years have been leakproofing, retaining walls also in good shape. Structure does not provide adequate access for generator repairs, clearance from electrical panels.	Consider replacing building to provide adequate clearance and access.

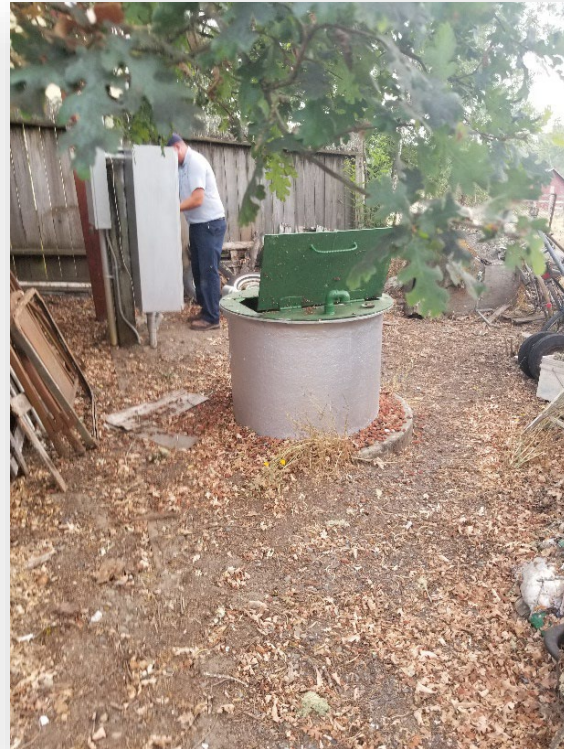
Site

Asset	Condition Rating	Performance Rating	Comments	Recommendations
Overall	-	-	If the District is looking to handover this facility to others for ownership and management, consider replacing entire lift station with a package system (pumps and controls) that vendor can maintain; equip with cellular (not dial-up); and consider alarm package appropriate for residential management.	
Pump 1	1	1	Recently replaced	None
Pump 2	2	1	Performing fine	None
Pump Guide Rails	2	1	Good shape. Pumps are pulled by hand with a rope.	Install pulley system for pump access.
Check Valve	1	1	Recently replaced	None
1/2-inch Gate Valve (x2)	4	3	Corroded	None
Wet Well	2	1	Serves only 2 homes, takes a while to fill. See Photo 4 below.	None
Wet Well Lid	3	3	Recently DIY fabricated approx. 1 year ago; rusting.	None
Inlet MH	2	1	Rehabbed approx. 10 years ago	None
Outlet MH	4	2	Corrosion on effluent pipe elbow	None
Access	2	4	Dirt path, difficult to access with equipment due to property owner belongings. See Photo 7 below.	Improve site to allow for easier servicing and equipment access.

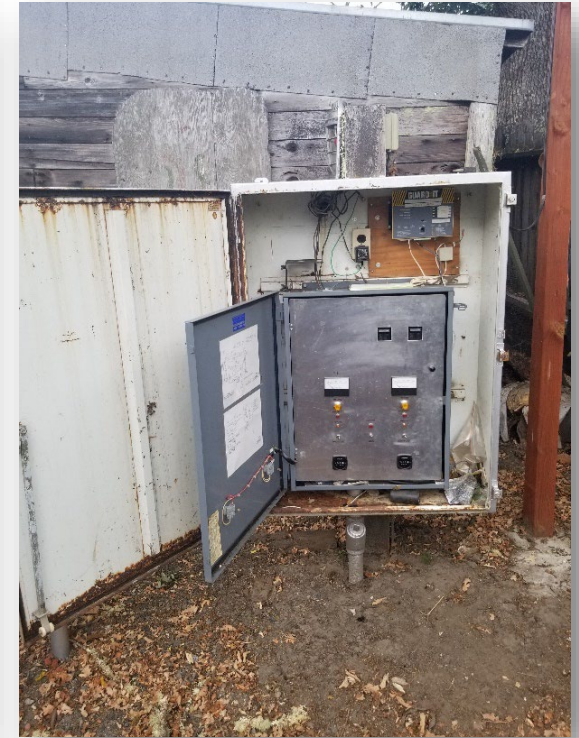
Control Panel

Security	1	1	Lock on electrical/control box	None
Meter/Control Housing	3	2	Corrosion along inside seals and bottom of box. See Photo 5 below.	None
Meter/Control Cabinet	1	1	In good shape, seals are good and no signs of corrosion. See Photo 5 below.	None
Electrical & Instrumentation/Controls	3	2	Seals on inner panel appear intact and components in acceptable condition. Outer enclosure is in corroded at bottom, potentially due to poor conduit seal from wet well instrumentation. See Photo 5 below.  Due to apparent age and modifications, all electrical, instrumentation, and controls assets/systems should be replaced.	Replace. Evaluate conduit and seals from wet well to panel for leakage before re-using.
