DATE: November 14th, 2024
TO: Members of the Board of Directors
FROM: John Gibson, Chief Plant Operator
SUBJECT: OCTOBER 2024 OPERATION REPORT

Lift Station #1, installation of new pump and slide rail system.

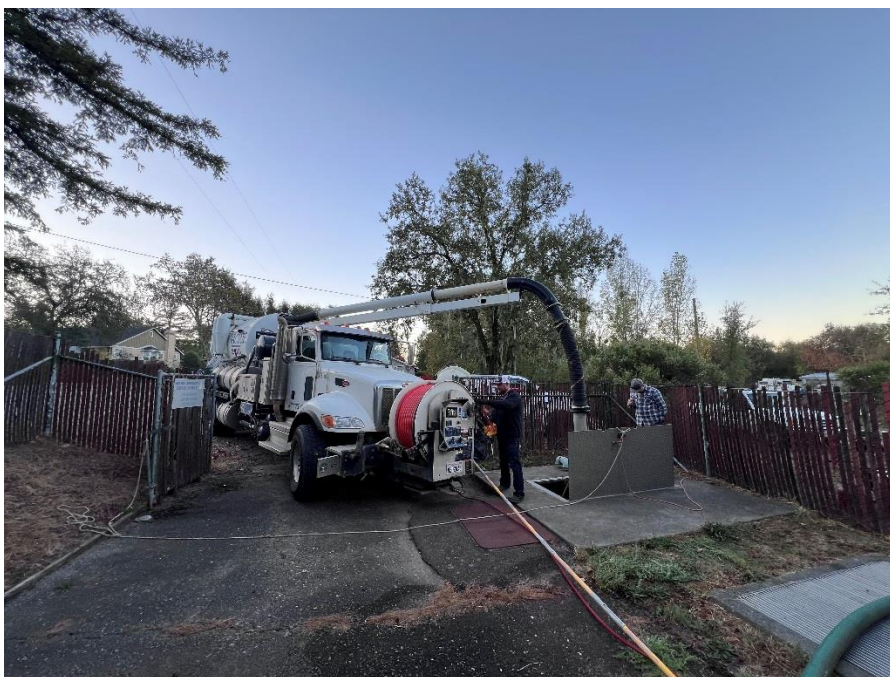
Miksis Services evacuated the lift station wet well prior to PumpMan’s installation work. The operators temporarily plugged the collection system and diverted the sewage flow around the lift station into the force main, ensuring the wet well remained empty for the duration of the installation.

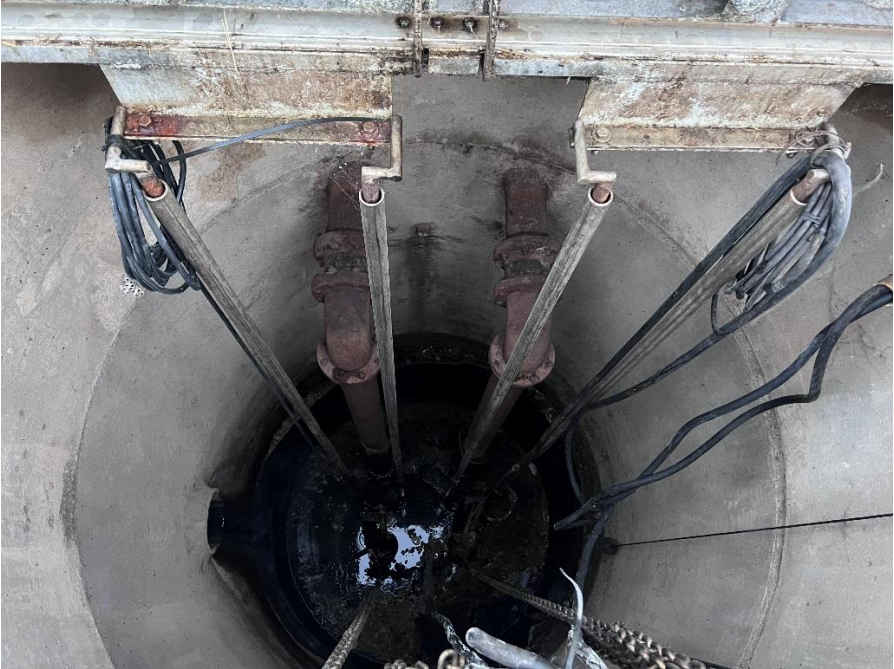
Original piping and slide rail system to be replaced.

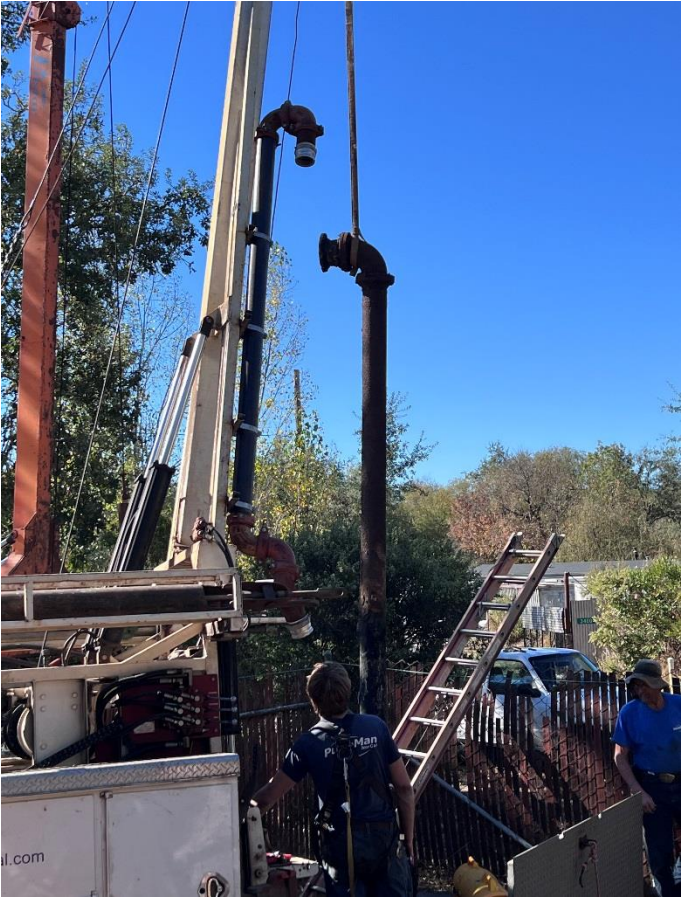
PumpMan removing a section of ductile pipe from the wet well.

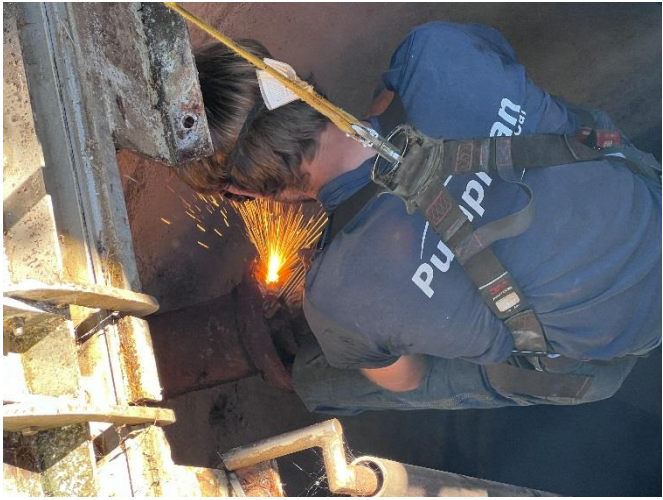
Photos of the removed piping suggest that the condition of the remaining force main is likely to be similar.

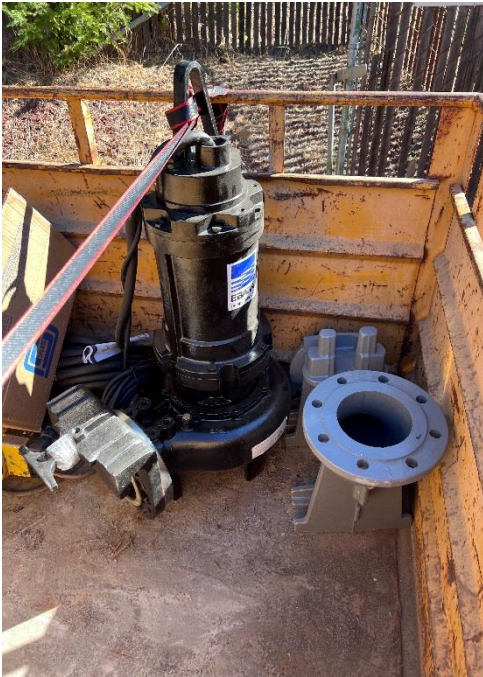
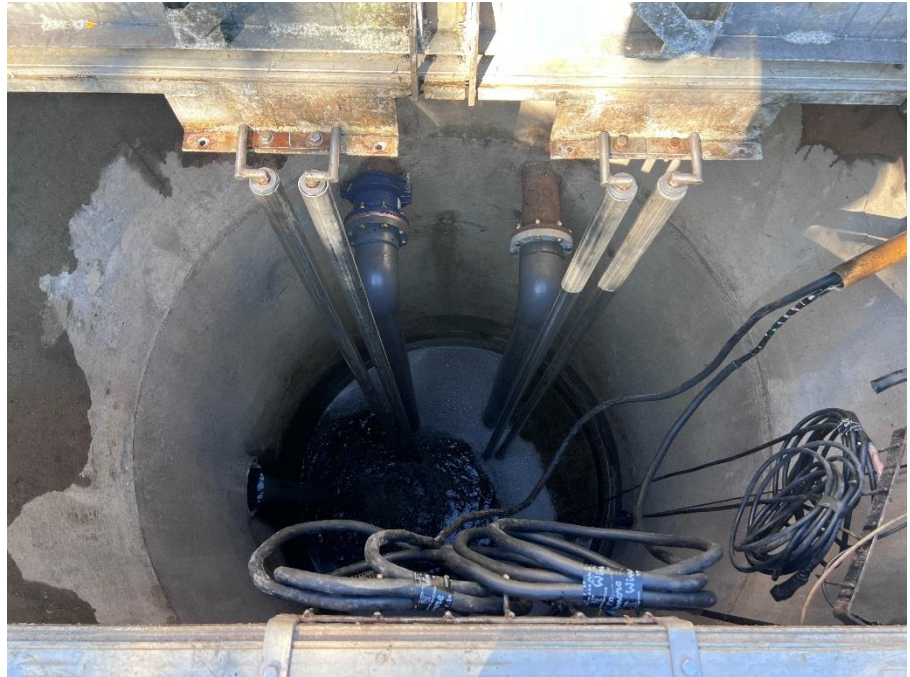
The installation of the new slide rail system was completed, and the annual cleaning of the wet well was successfully performed. With the new standard rail system in place, GCS D now has more flexibility for future pump replacements. The system was tested, and no leaks were detected. With the upgraded system, the mating surfaces of the pumps and bottom elbows seated properly without any bypass. As a result, the time required to pump down the wet well was reduced by one-third.
