DATE: June 6th, 2023

FROM: John Gibson, Chief Plant Operator

SUBJECT: OPERATION REPORT: June, 2023

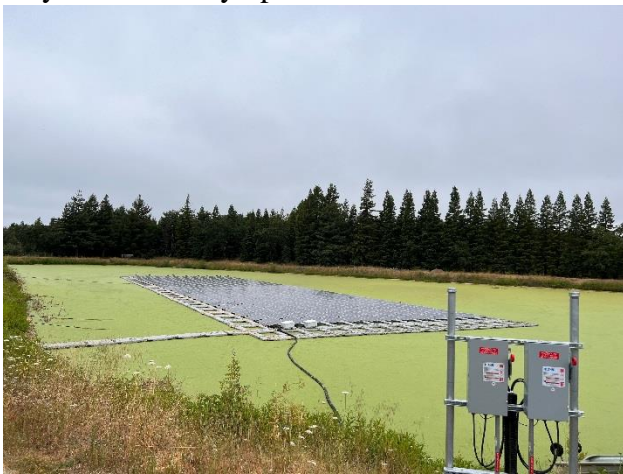
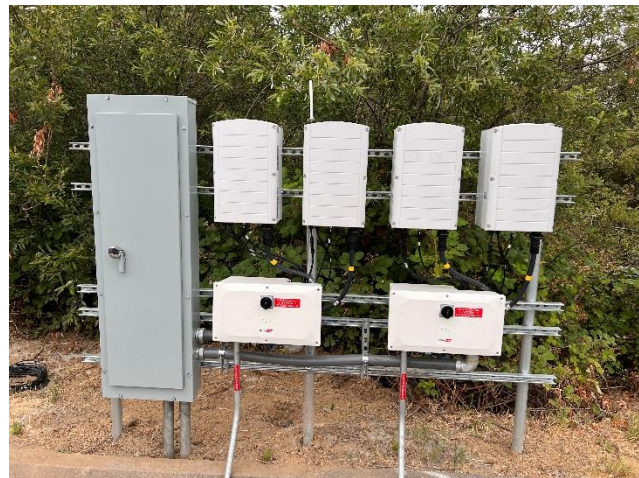
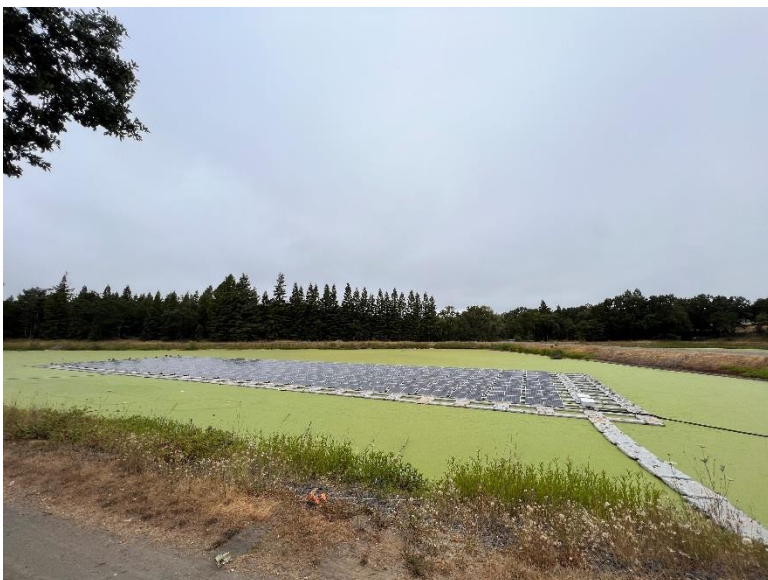
6. Solar Panels:

The installation of the floating solar panels in the West holding pond has been completed successfully, and they are now fully operational.
