FROM: John Gibson, Chief Plant Operator
Reviewed By Chad Davisson, GM

SUBJECT: OPERATION REPORT: May, 2023

Operations Report: Operations, Process Control, and Preventative Maintenance

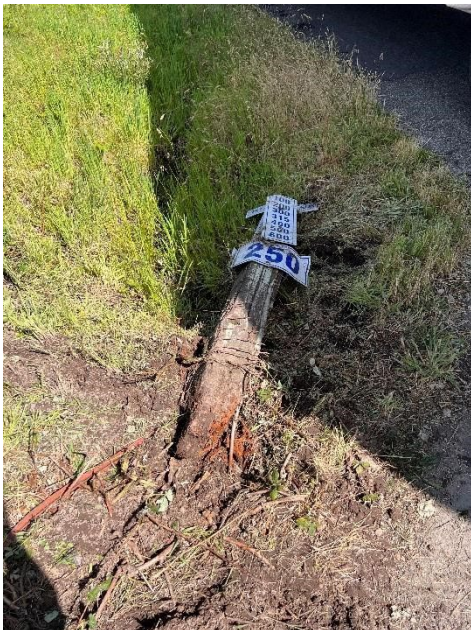
Before

- Replaced the address post located near the roadway, which had been knocked over by a delivery truck.

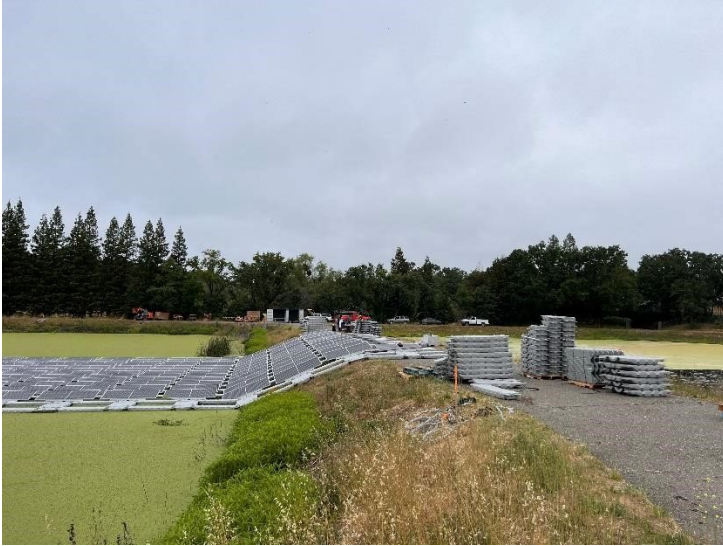
11. Solar Panels:

North Coast Solar is currently in the process of installing floating solar panels in the West holding pond. The installation is ongoing and progressing smoothly.
