Sanitary Sewer System Preliminary Engineer's Report

Graton Community Services District

Project No. 1088-40-24-03

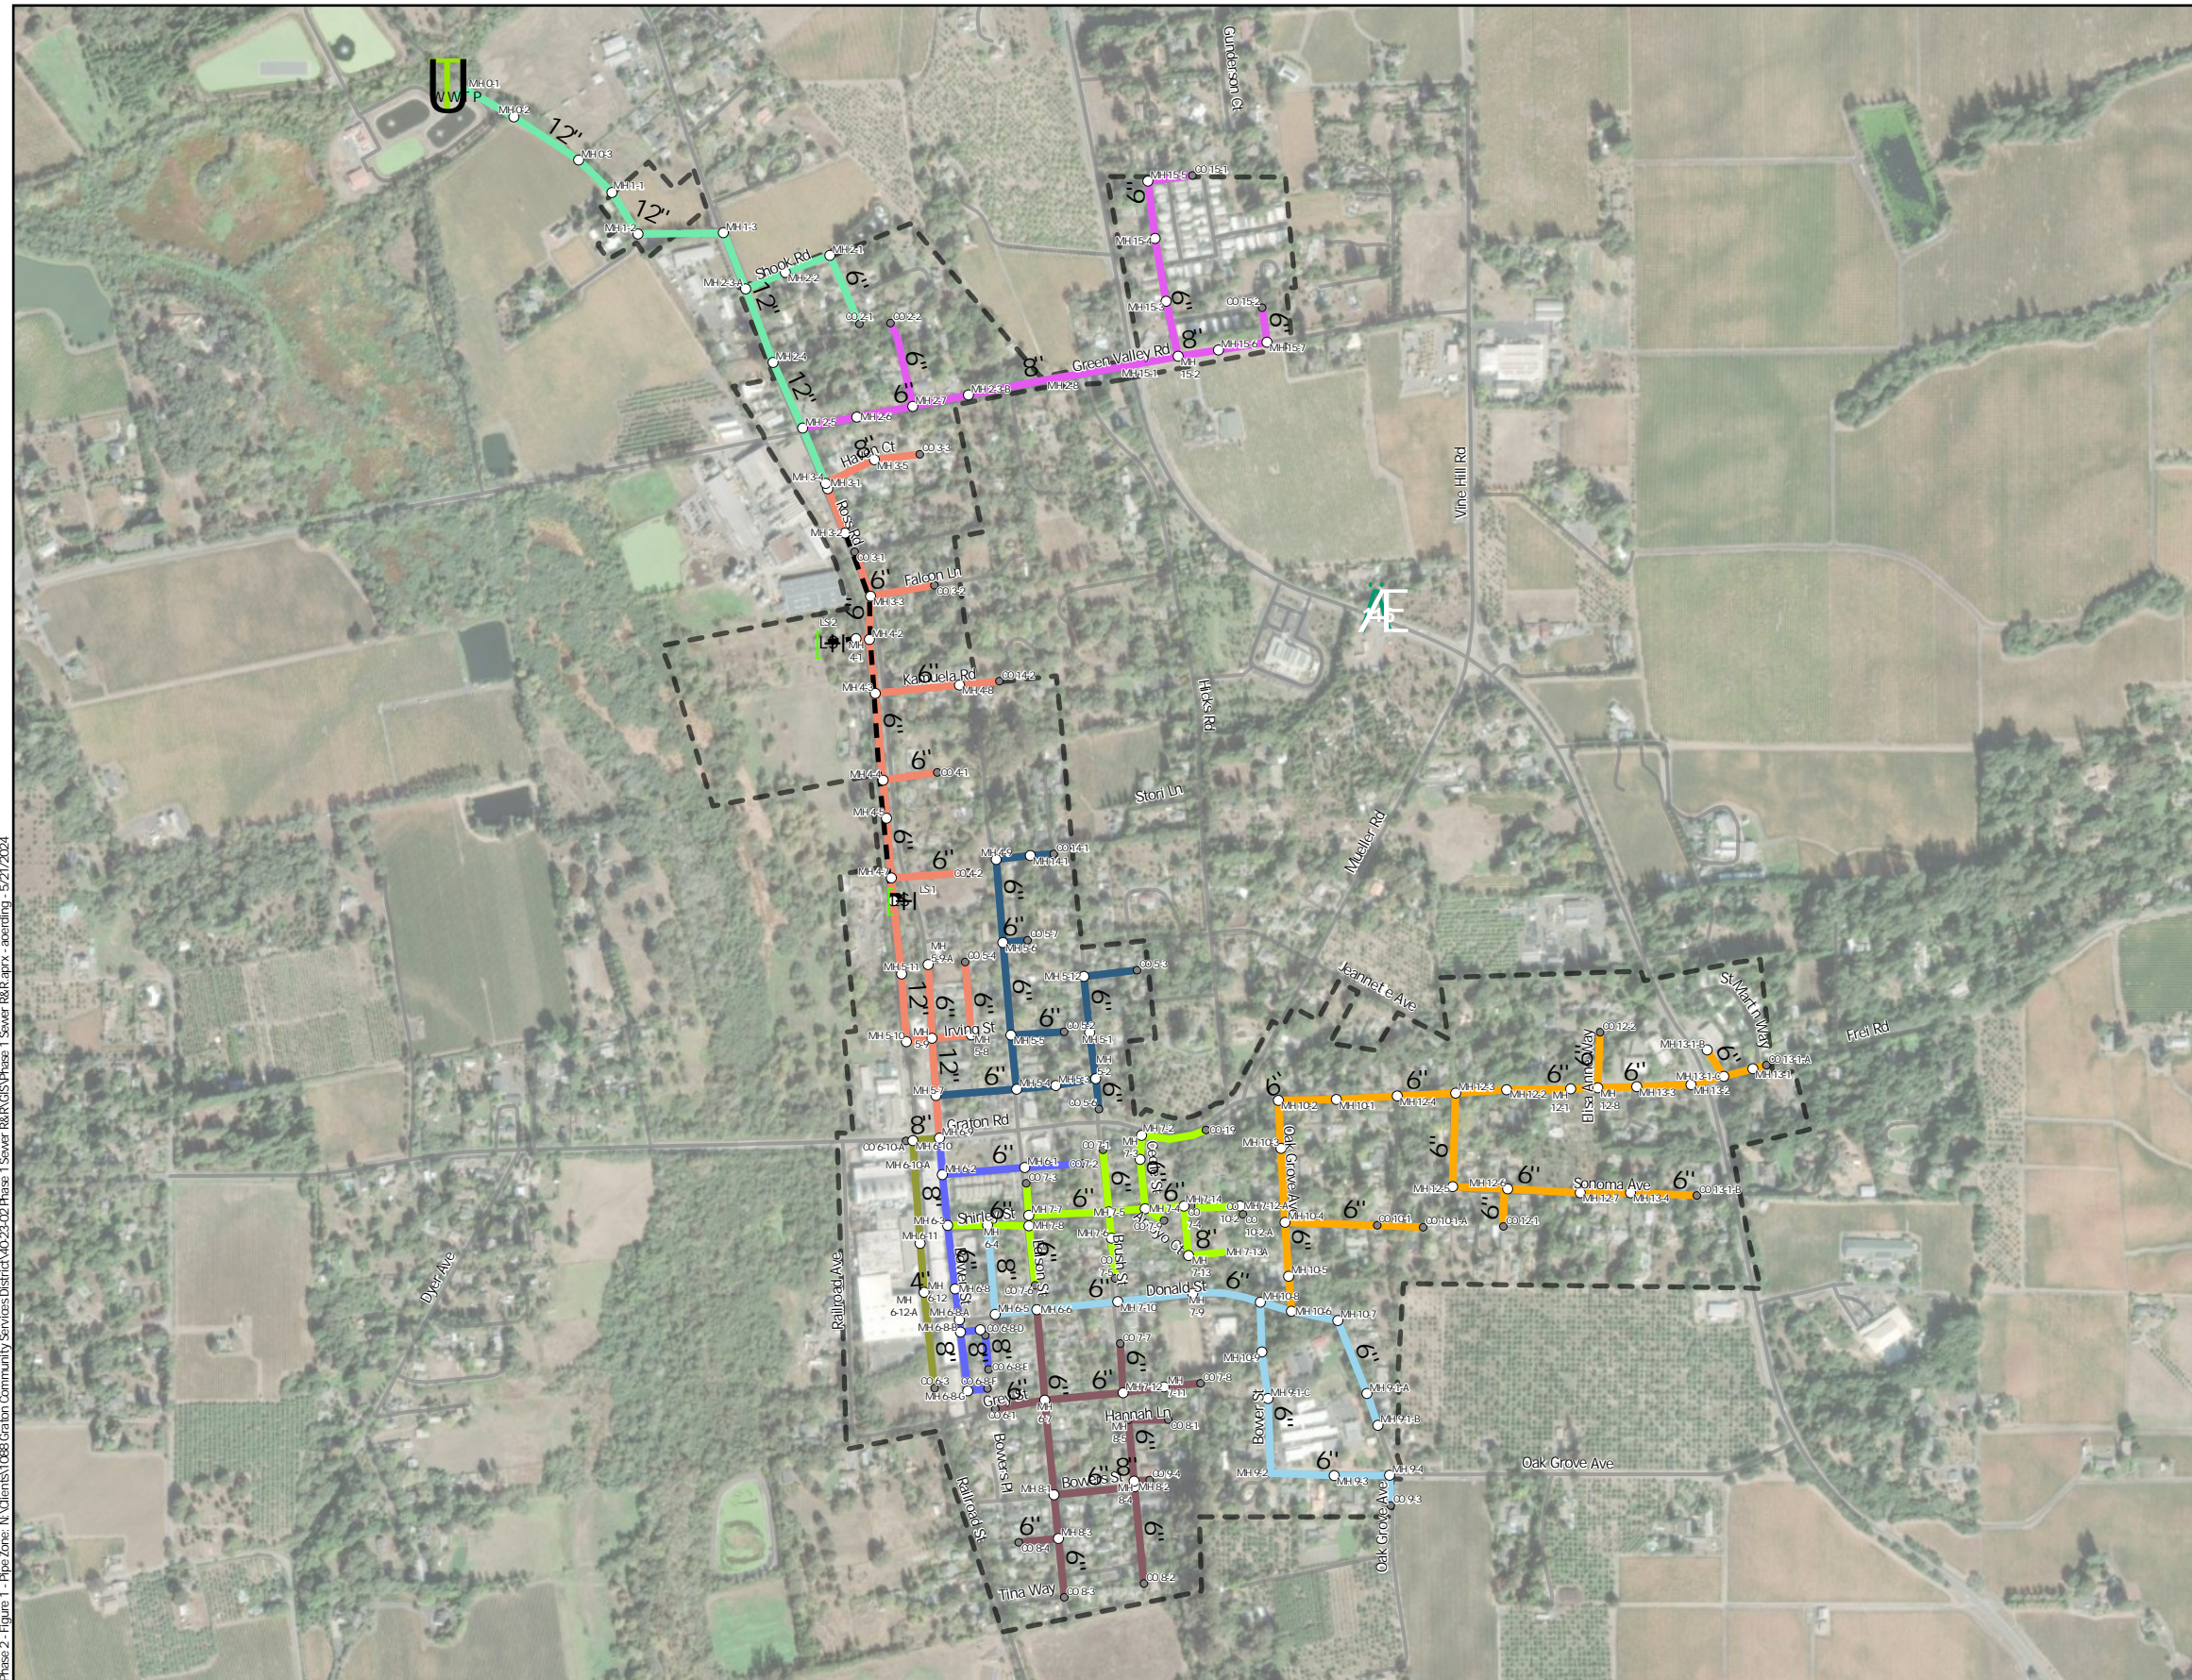
Figure 1

The Graton collection system includes several areas/neighborhoods which have been given names, as shown in Figure 1. This is primarily for the purpose of organizing the pipeline inspection results and recommendations. Pipeline diameter and manhole IDs are also shown on Figure 1.
