GRATONCOMMUNITY SERVICES DISTRICT

SUBJECT: OPERATION REPORT, July 15th – August 11th 2022

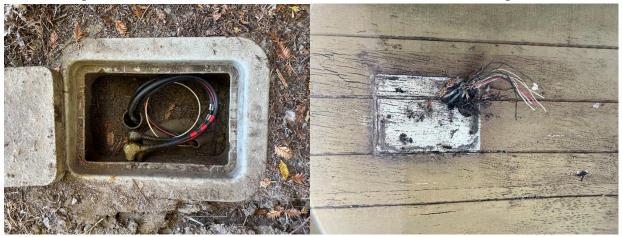
The electrical box has been disconnected from the shed and the wiring tidied up in an underground Christy box. Pending a start date for the teardown and removal from Heauser Hauling.

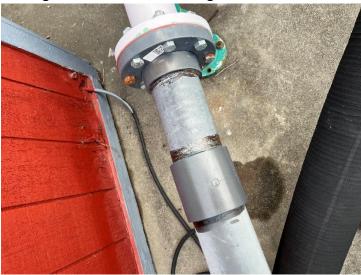
Replaced the 4"X16' effluent pump pvc piping with a flexible hose and camlock fittings. This will
prevent future maintenance costs due to vibrations and water hammer on startup and shutdown
causing leaks and breaks at the glued connections.
